Situation Photo Log

Thursday, February 14, 2013

Kalamazoo River / Enbridge Spill

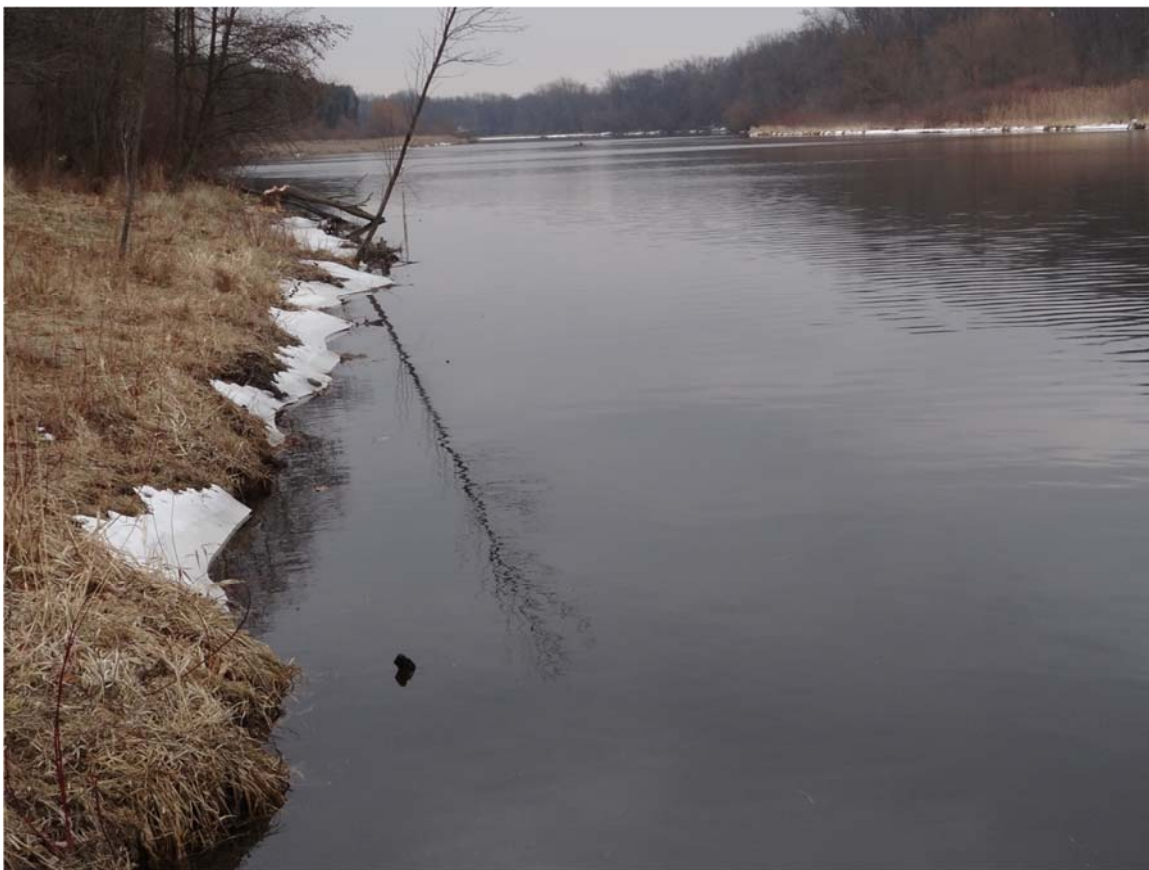
1. C0.4 Boat launch river icing conditions.

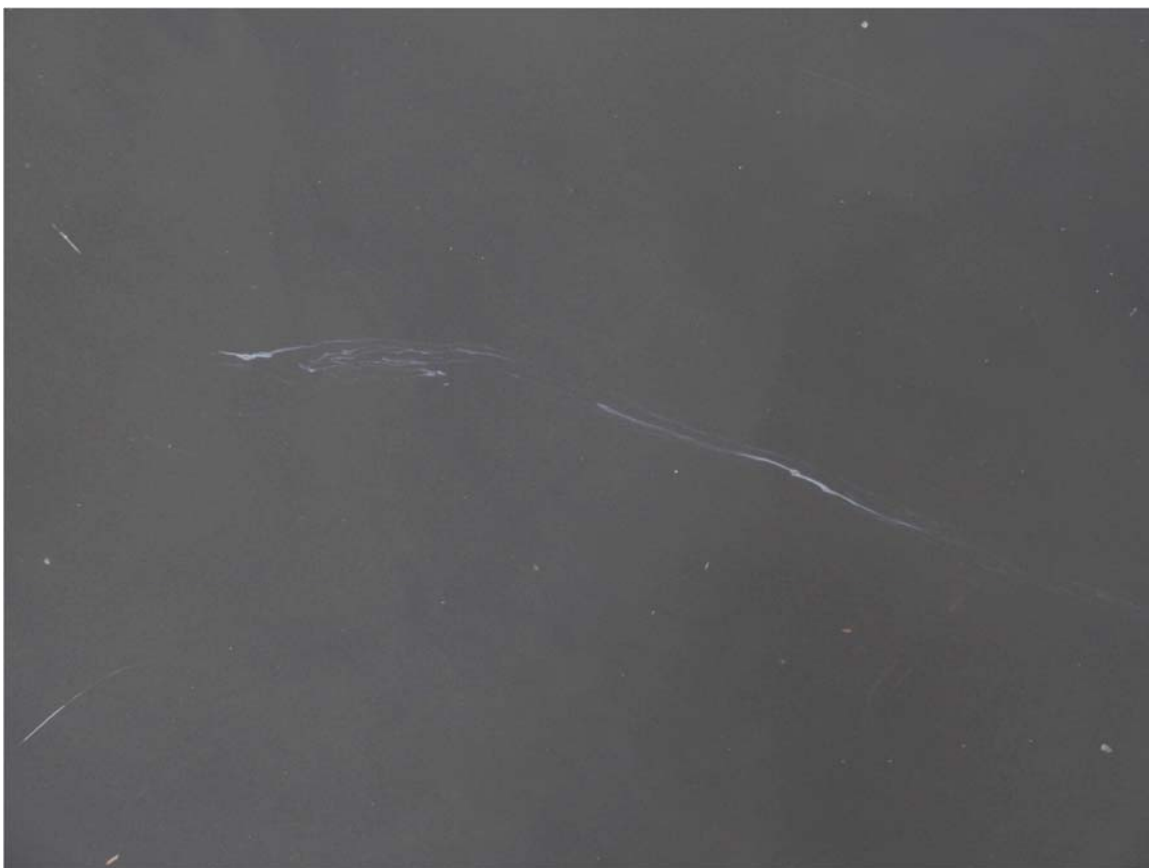
2. MP5.10 C0.4 Boat launch sheen and tar globs observed.

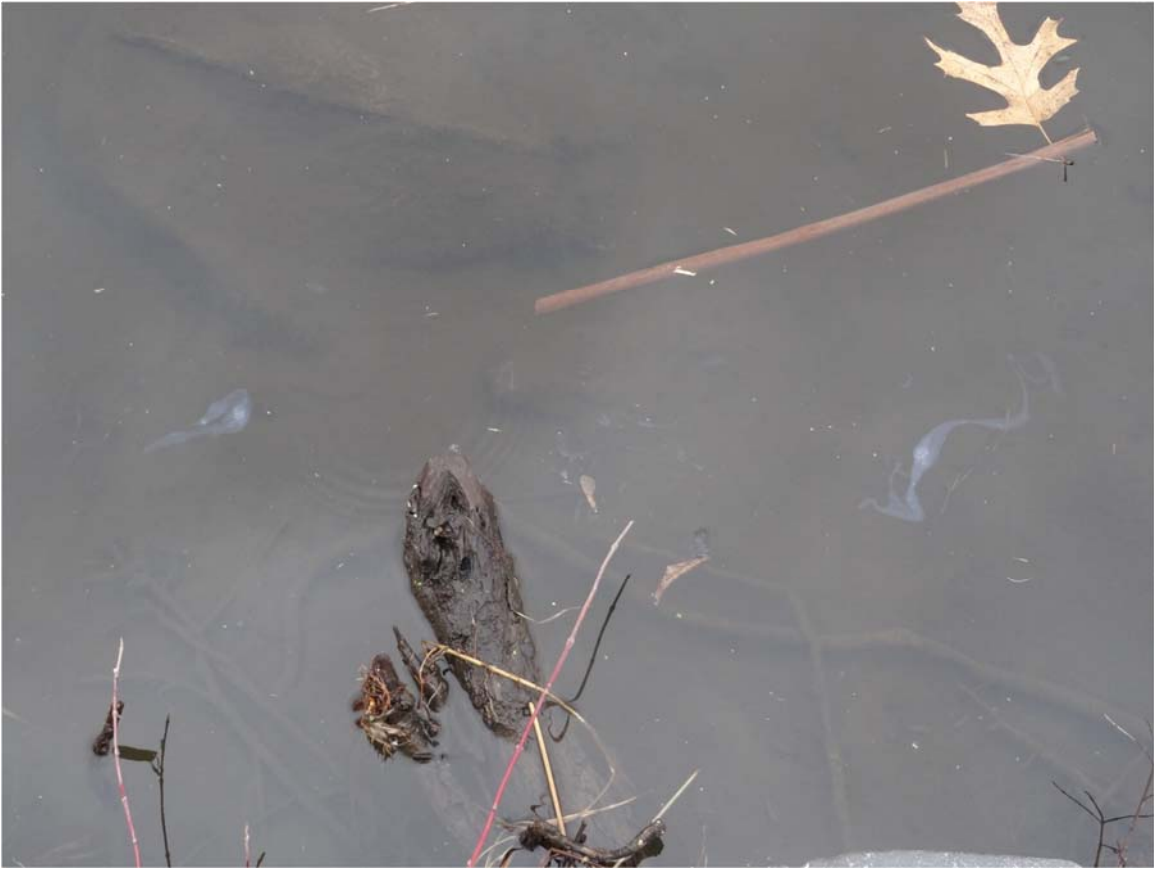
3. MP5.10 C0.4 Boat launch sheen and tar globs observed.

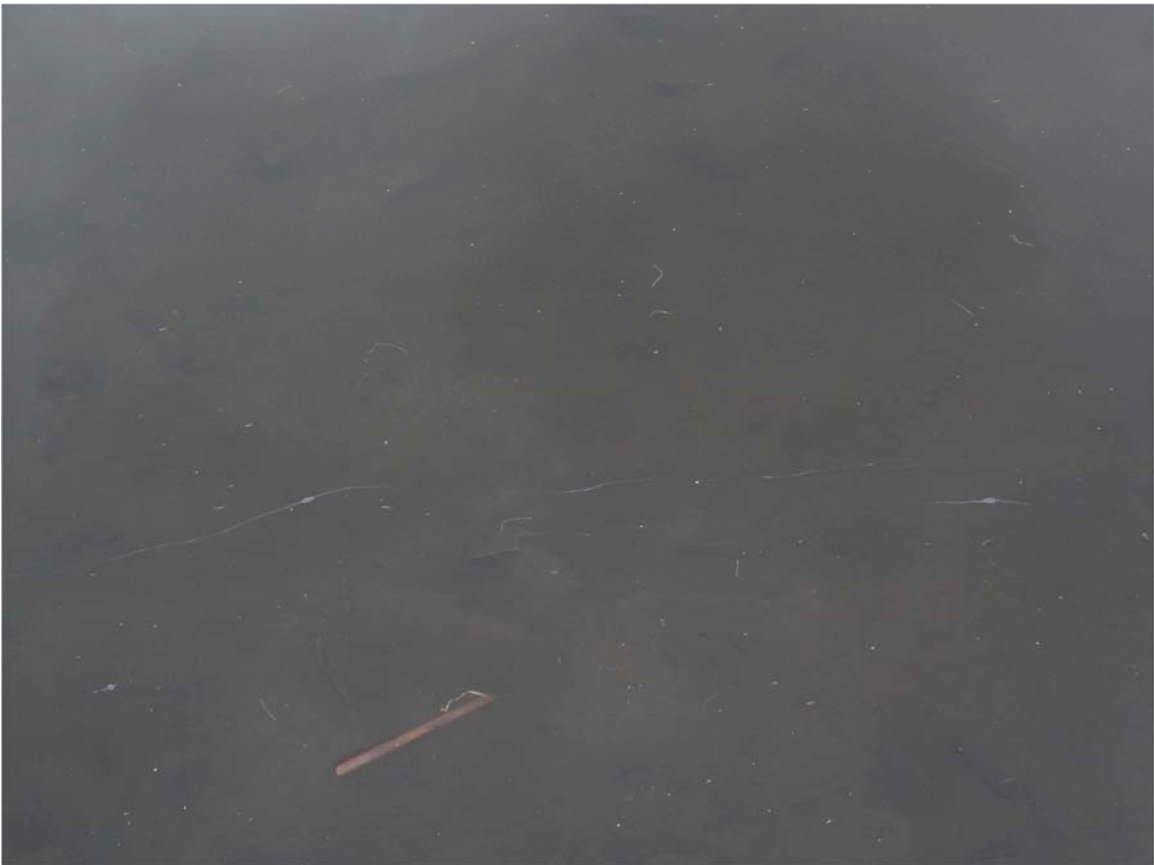
4. MP5.10 C0.4 Boat launch sheen and tar globs observed.

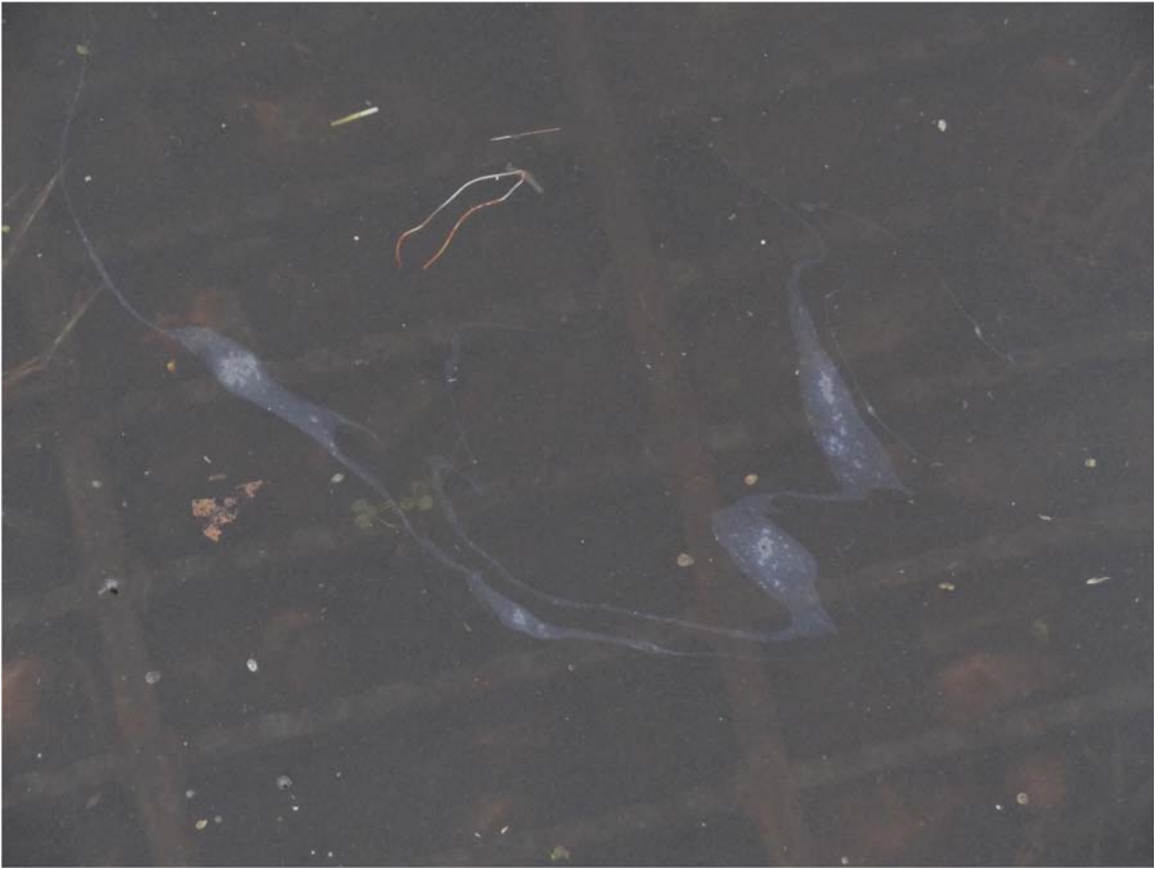
5. MP5.10 C0.4 Boat launch sheen and tar globs observed.

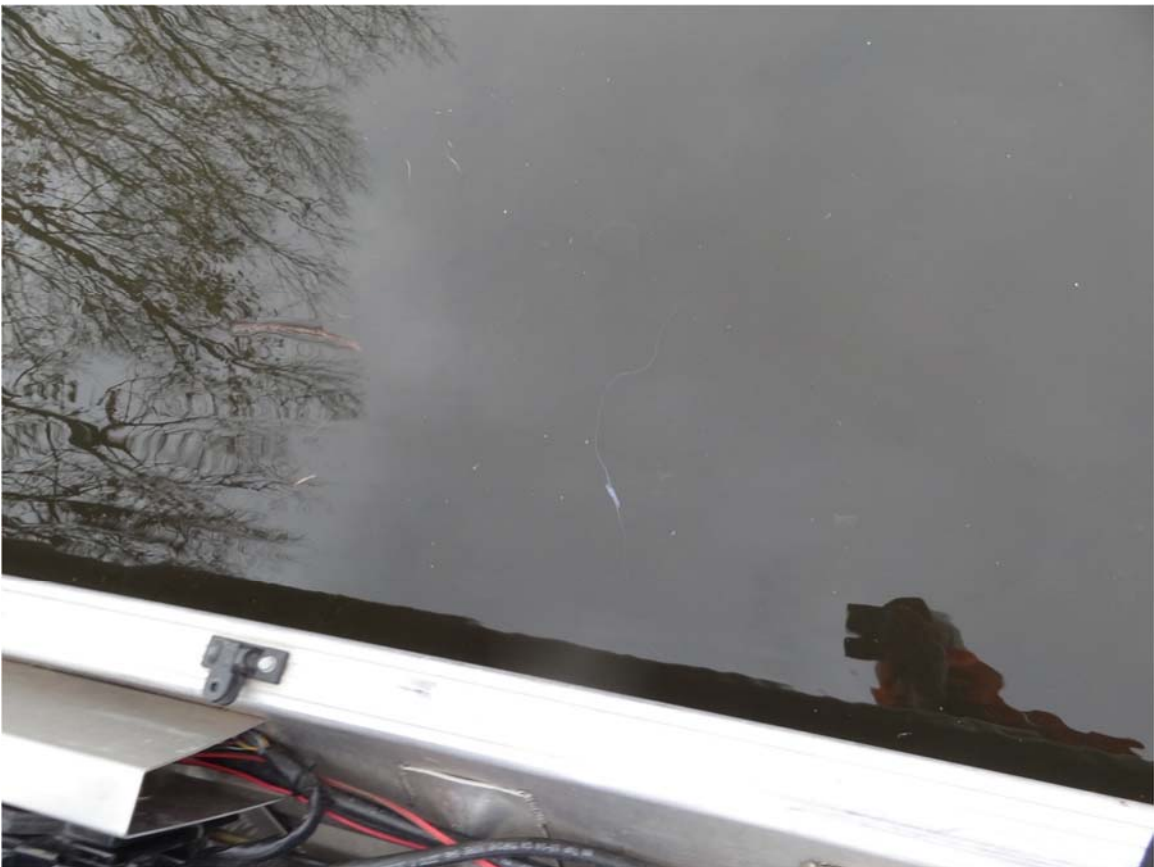
6. MP5.25 RDB sheen and tar globs observed.

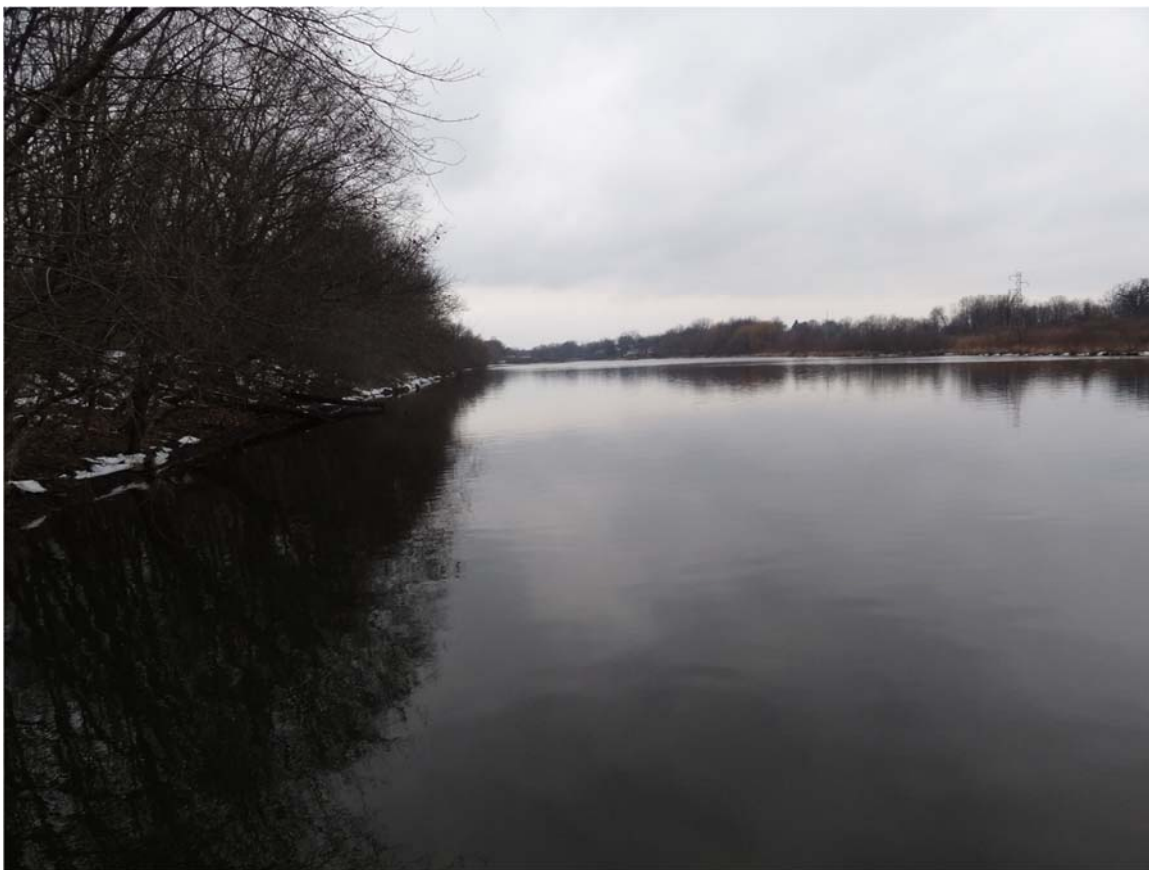
7. MP5.25 LDB area where sheen and tar globs were observed.

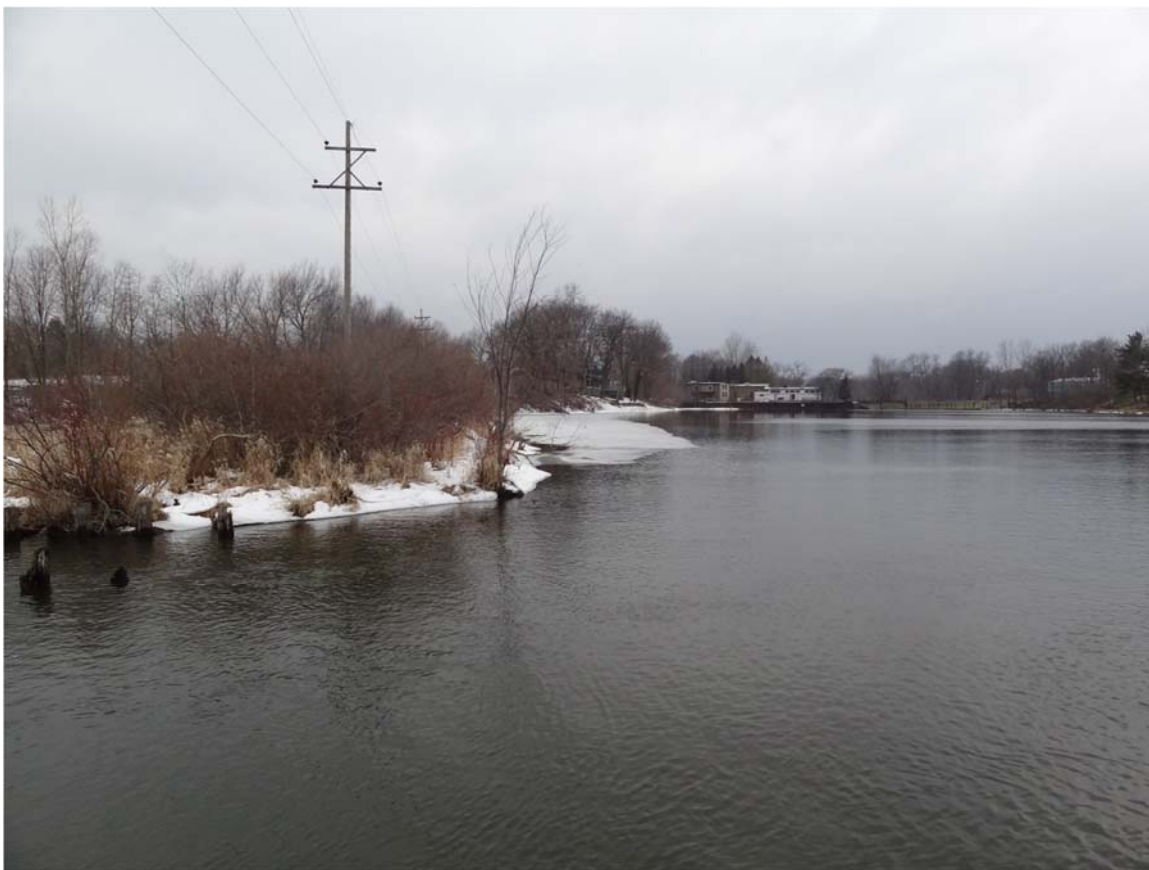
9. MP5.63 Ceresco Dam impoundment icing conditions.

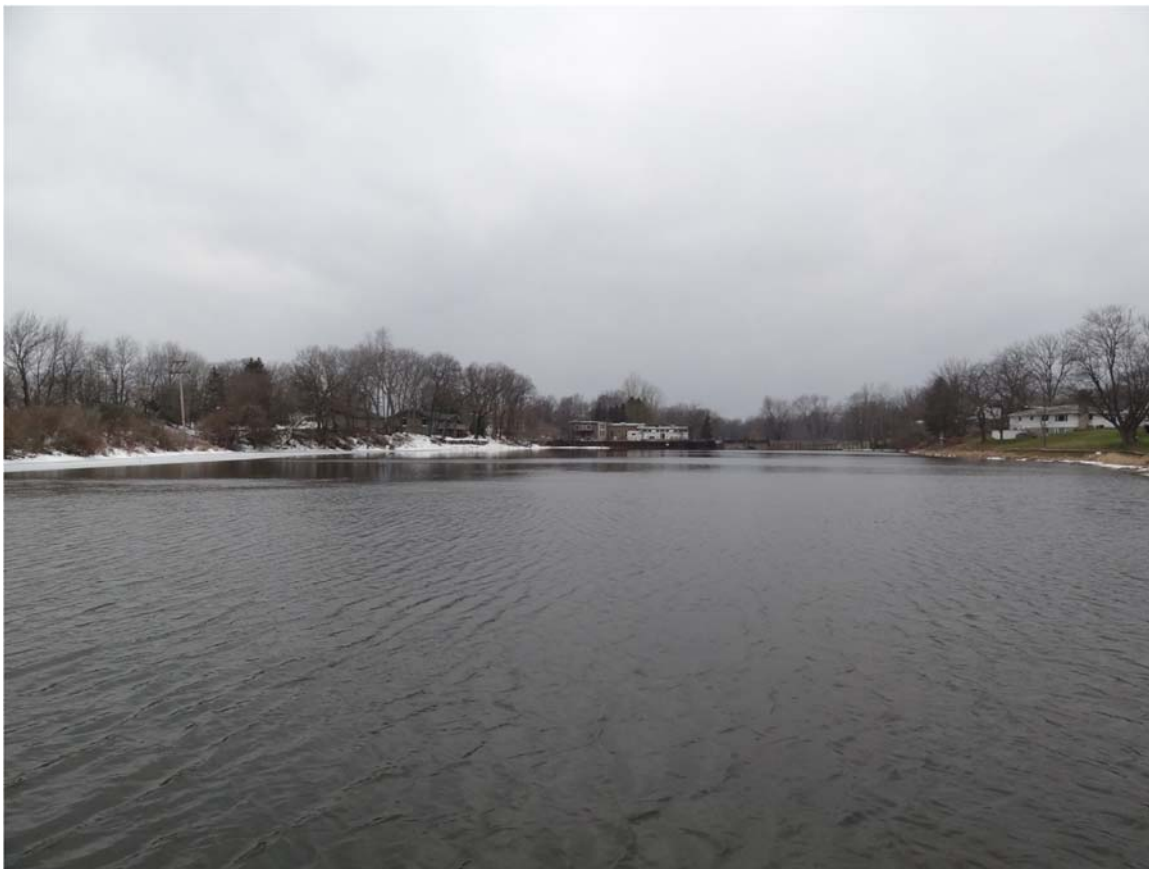
10. Ceresco Dam impoundment icing conditions.

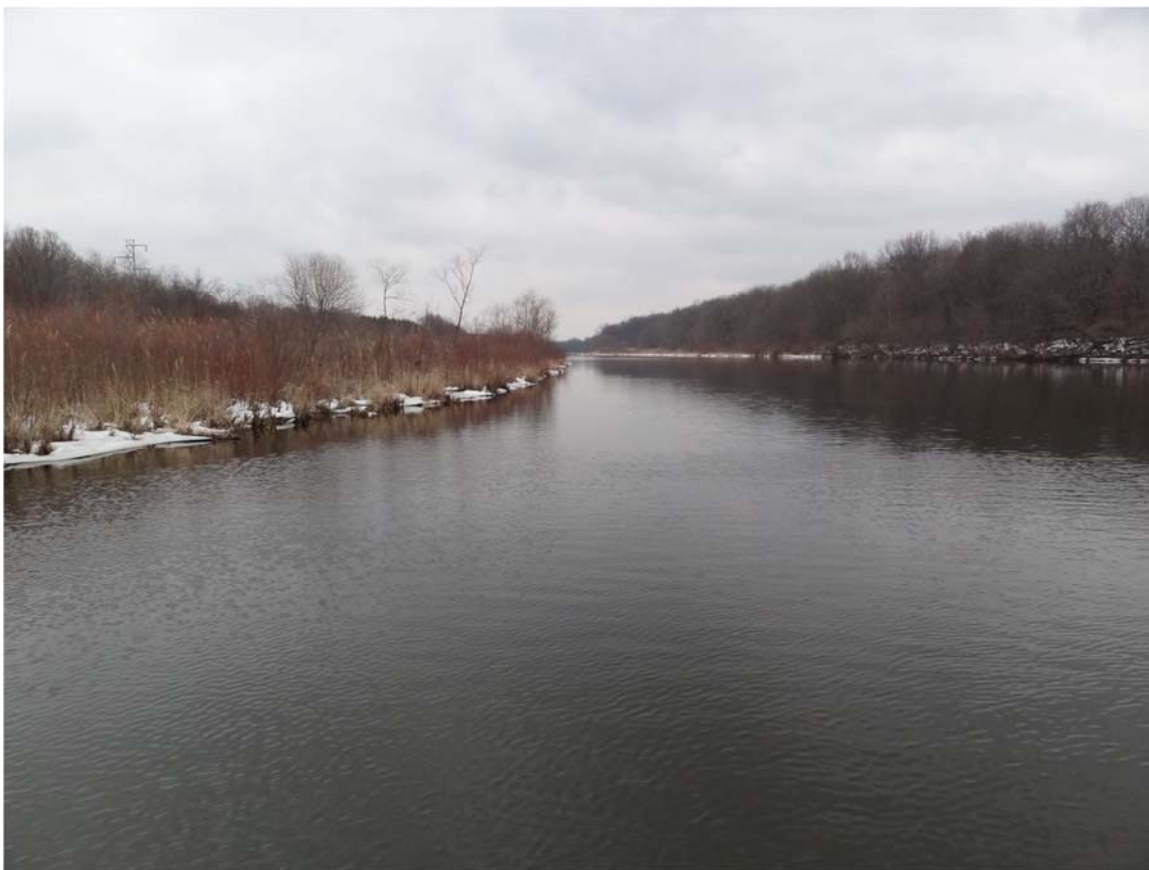
11. MP5.35 RDB area where sheen and tar globs were observed.

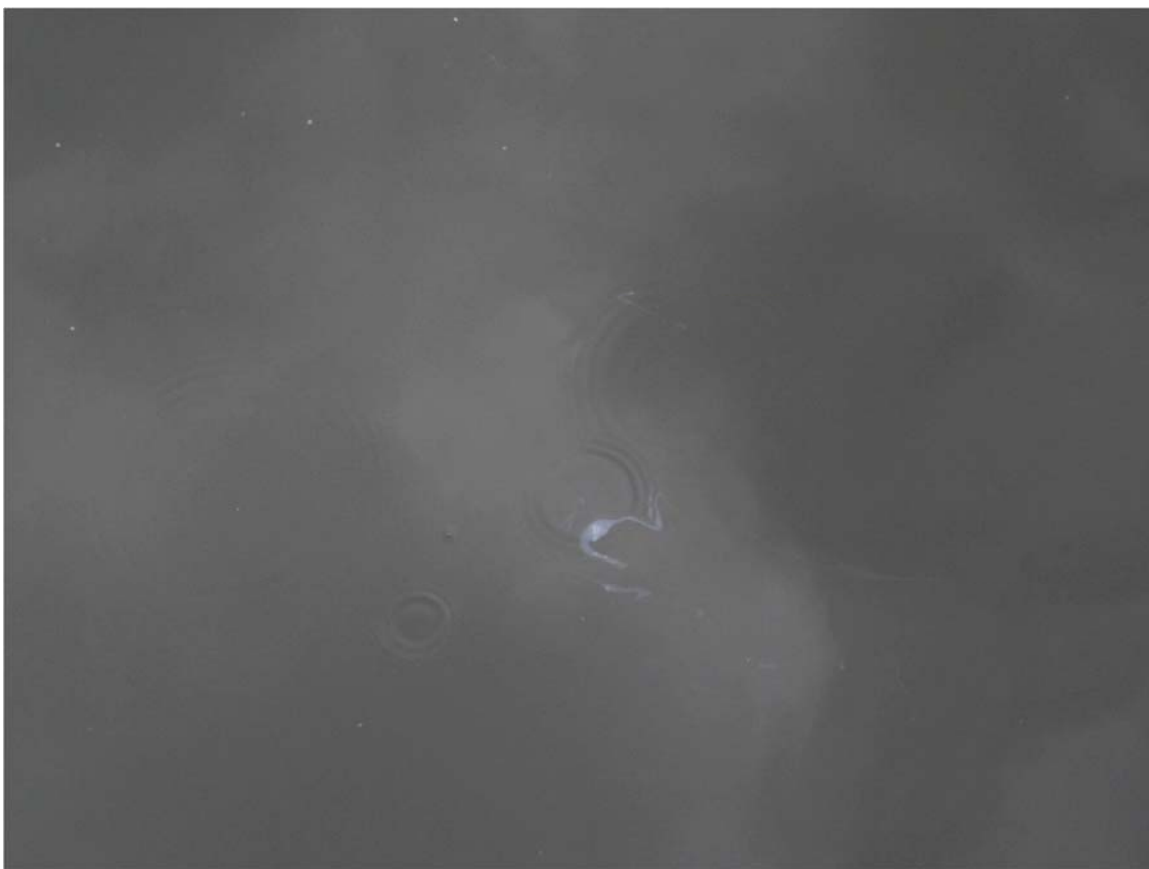
12. MP5.35 RDB sheen and tar globs observed.

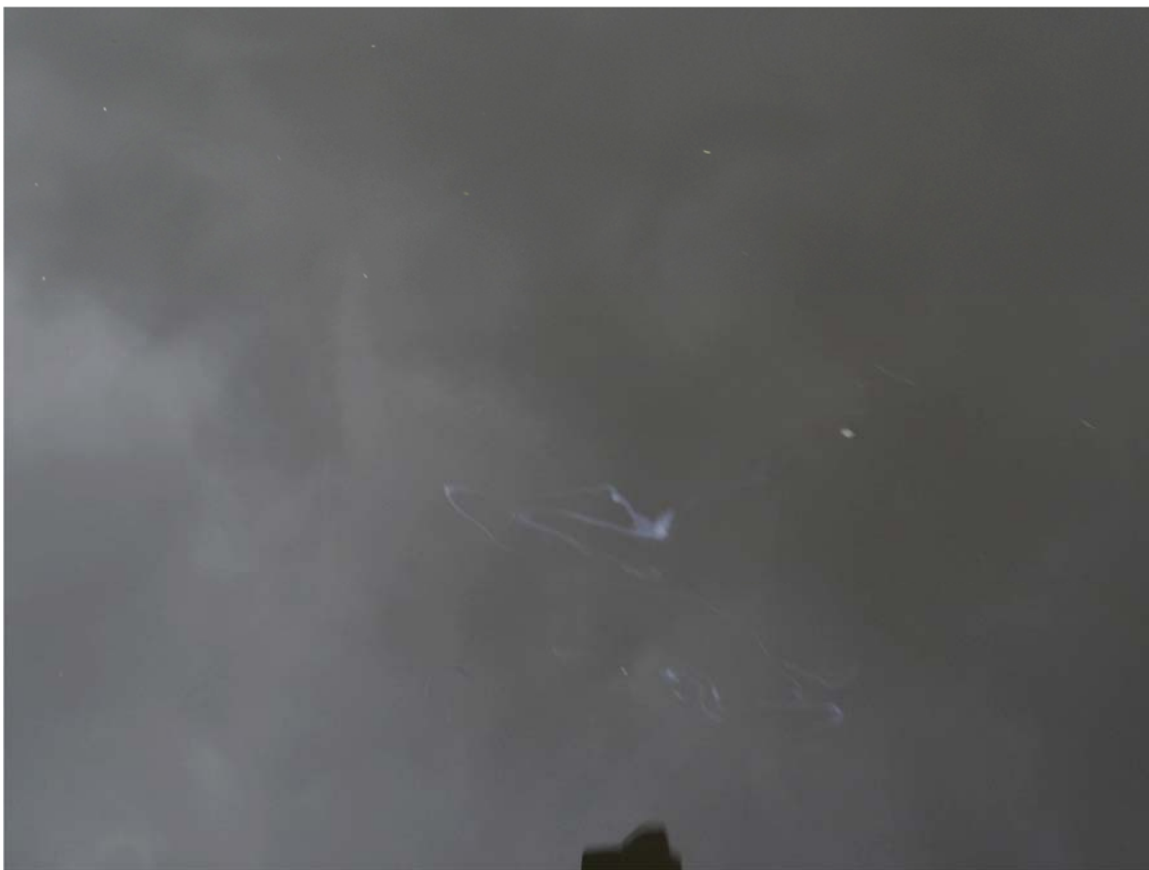
13. MP5.35 RDB sheen and tar globs observed.

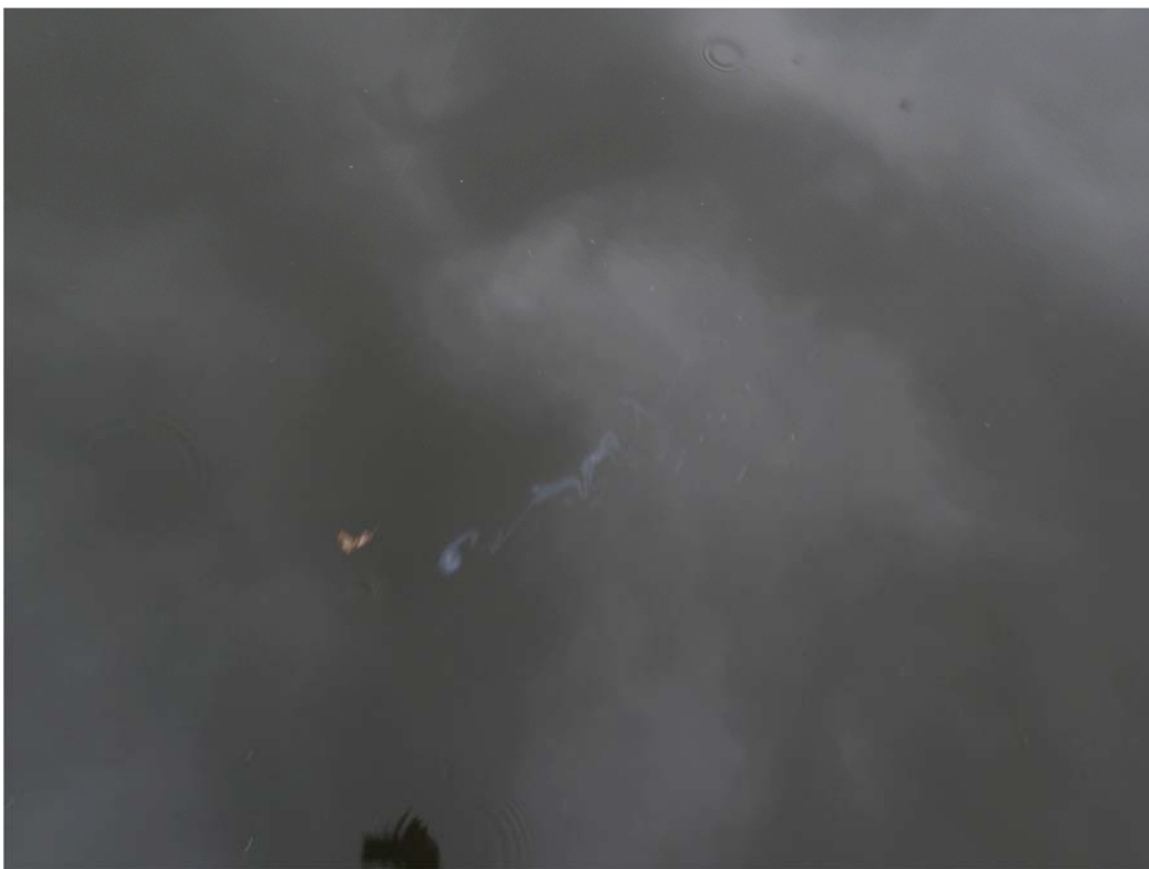
14. MP5.30 RDB sheen and tar globs observed.

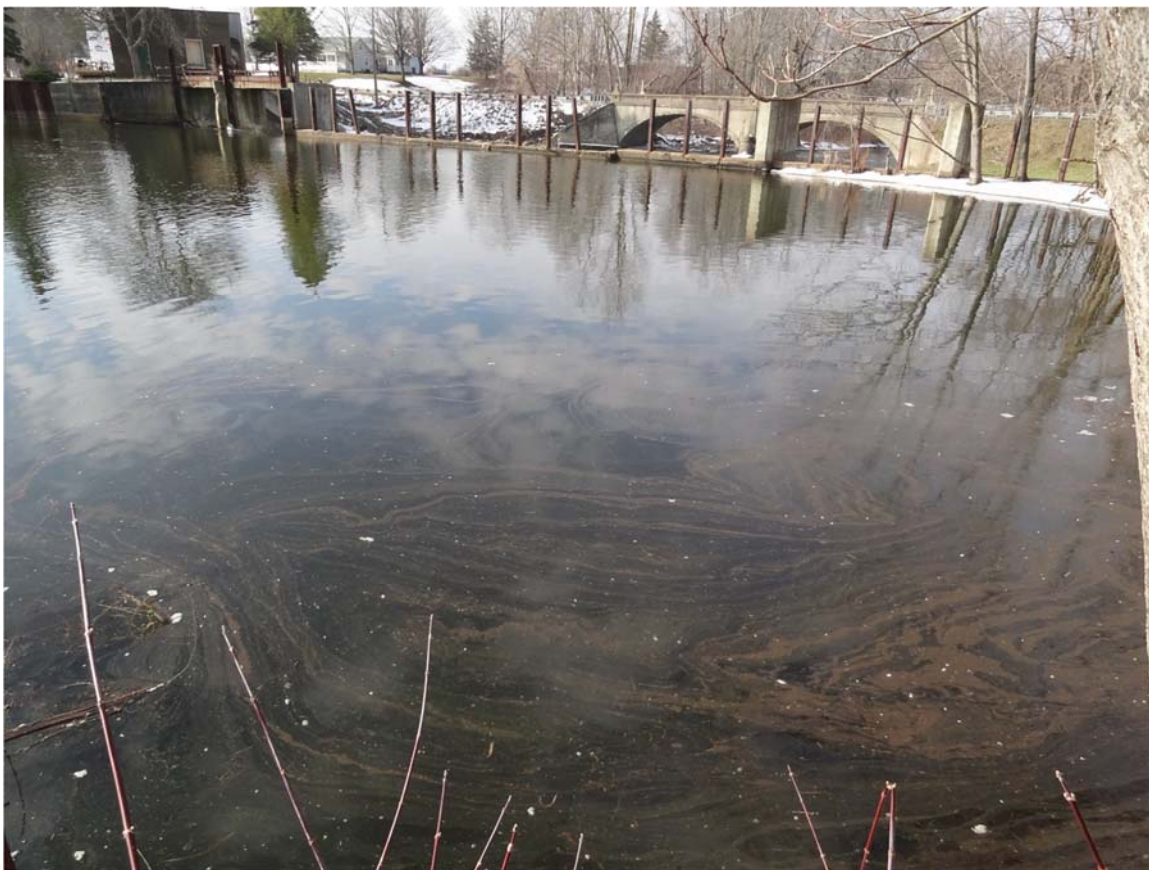
15. MP5.89 RDB observed a bio film.

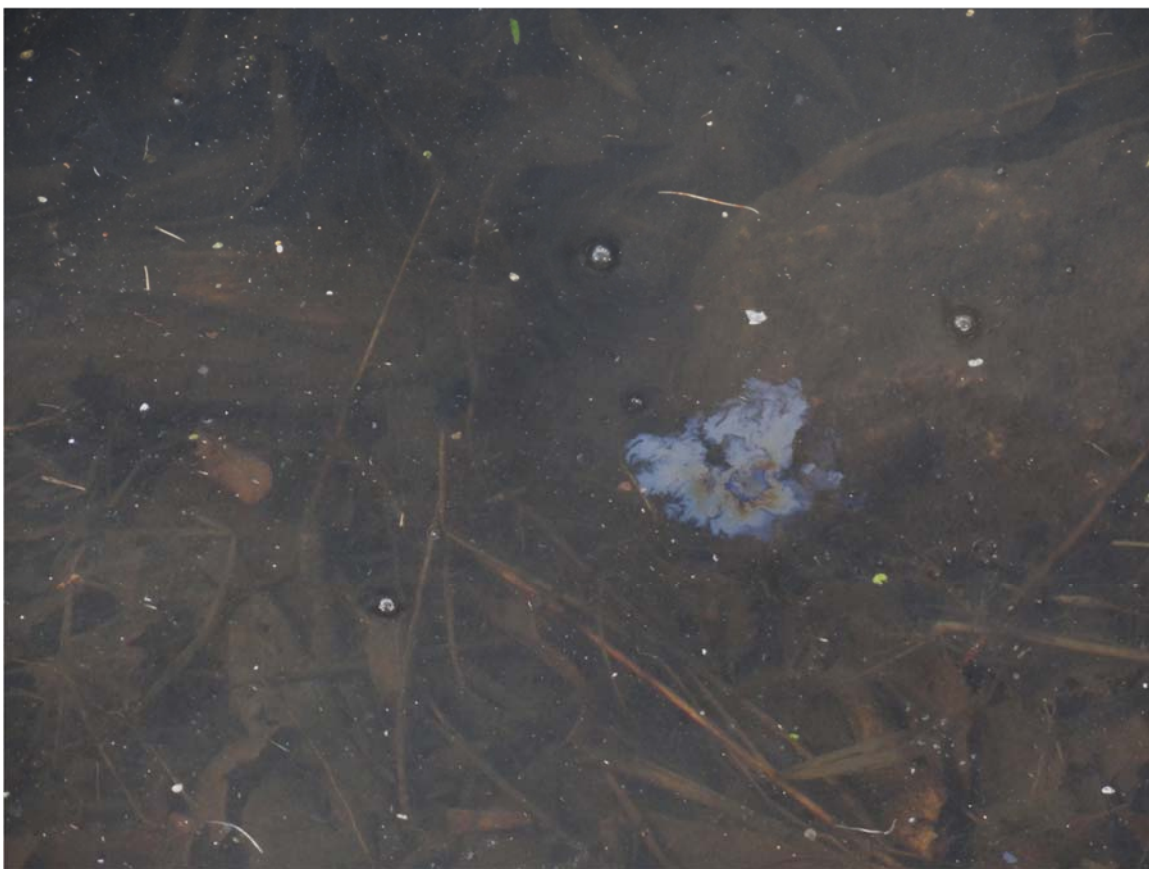
16. MP5.89 RDB sheen and tar glob observed.

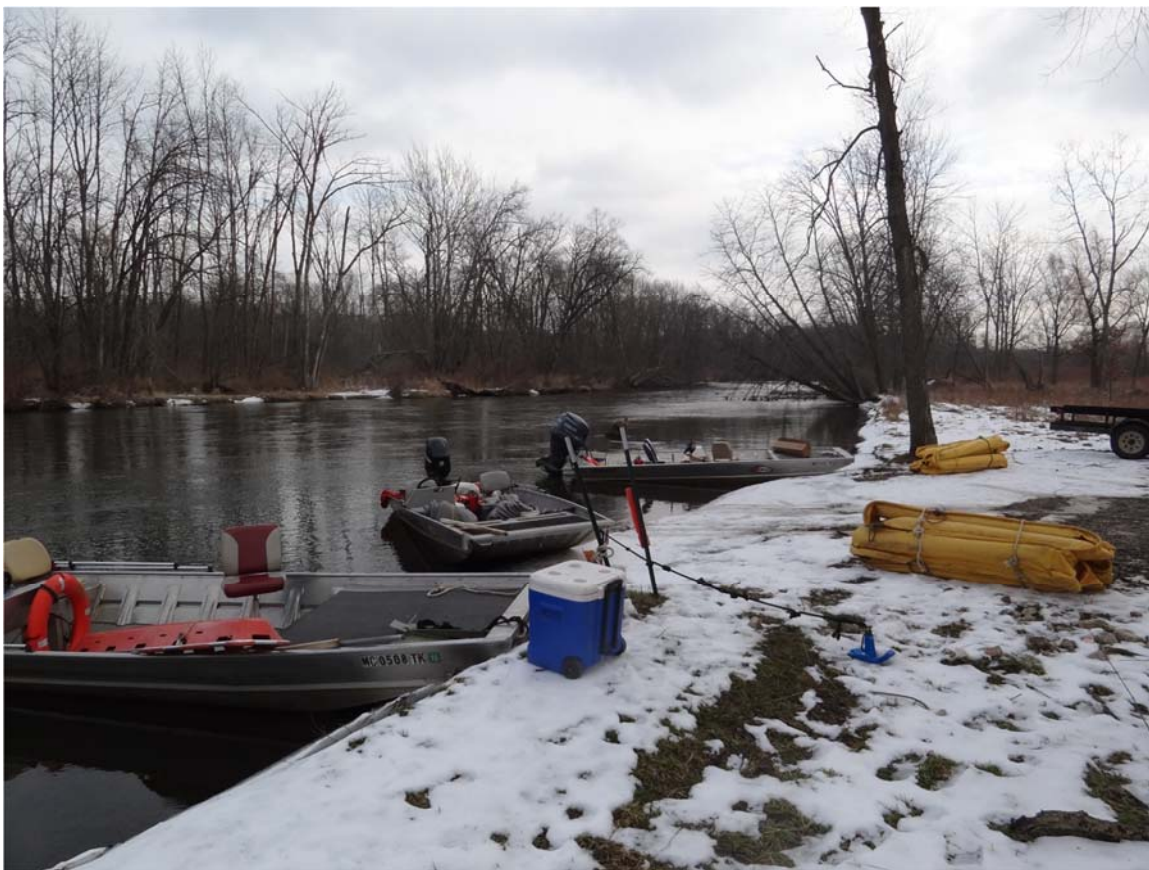
17. C3.2 Boat launch observed crews preparing to repair the damaged MP10.75 sediment trap tree structure.

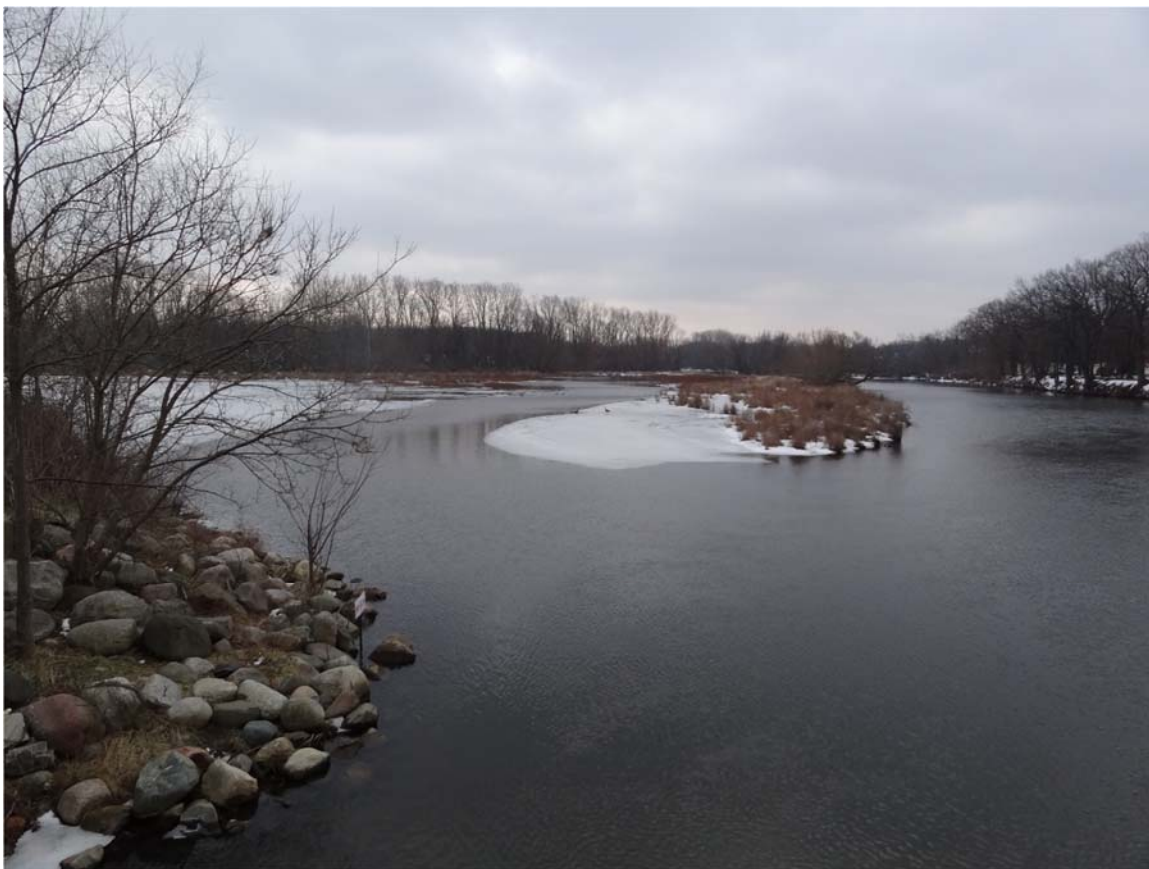
18. MP15.25 South Mill Pond river icing conditions.

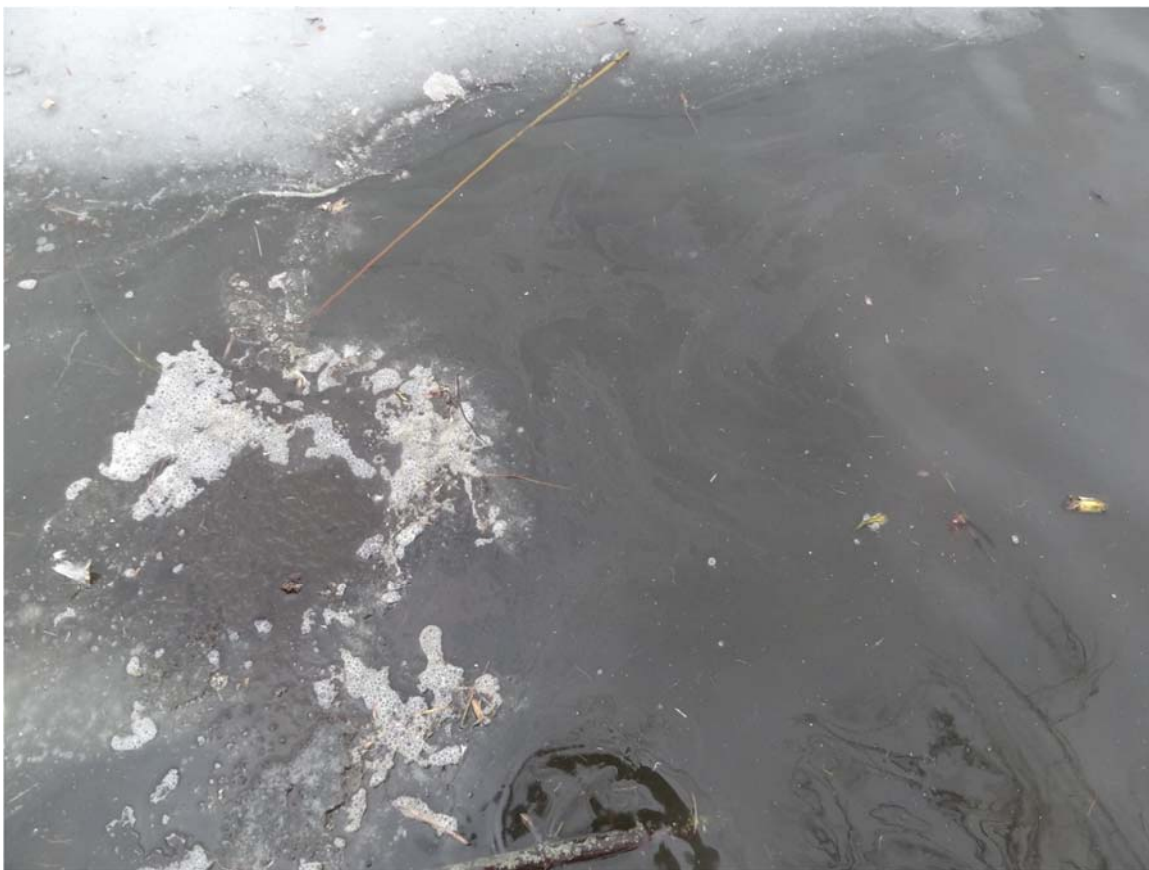
19. MP15.25 South Mill Pond observed sheen.

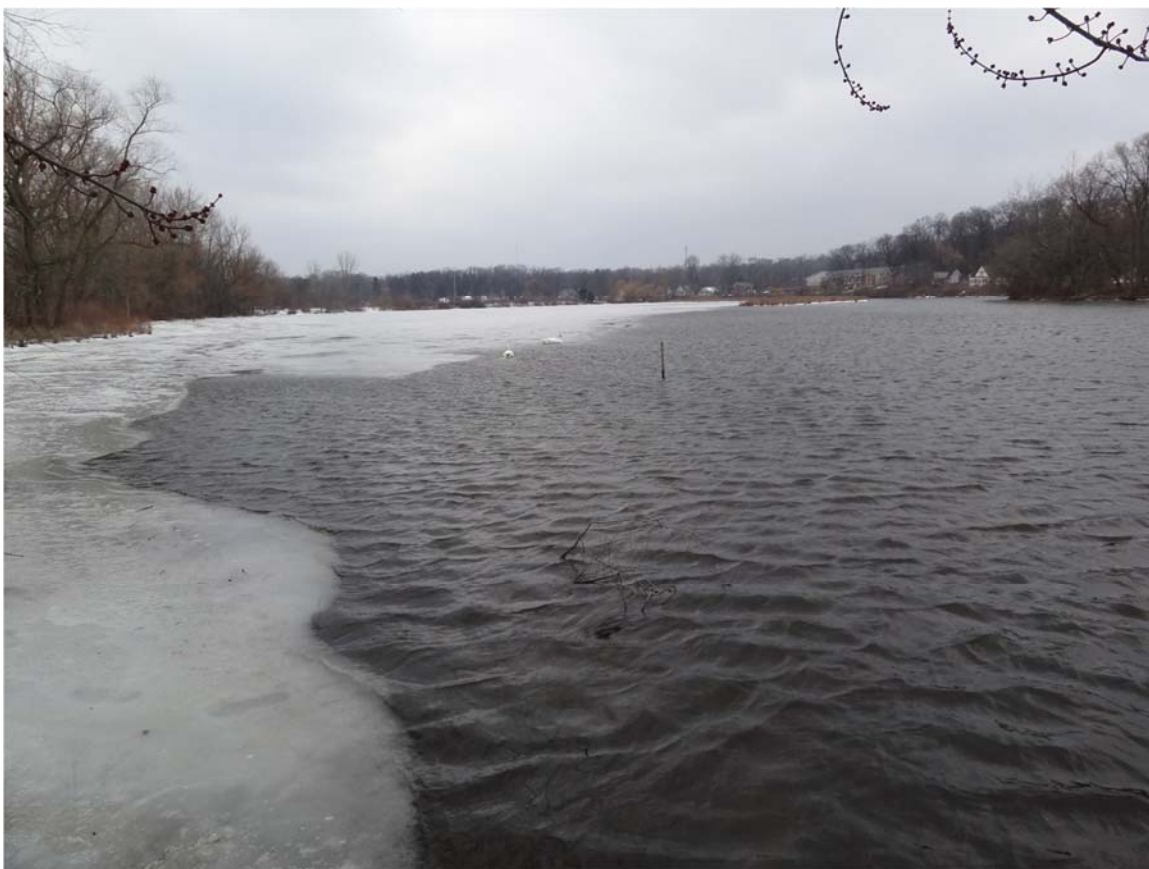
20. MP15.75 North Mill Pond river icing conditions.

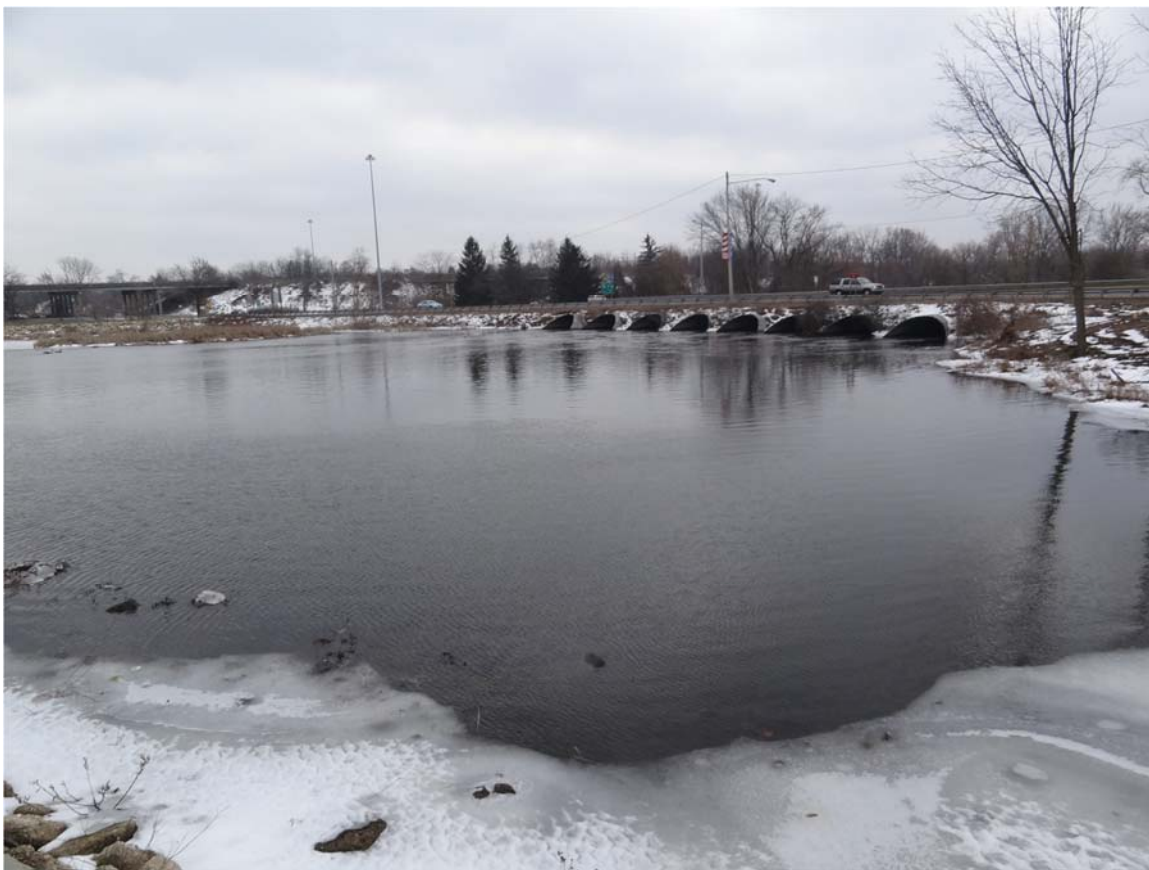
21. MP15.75 Battle Creek Spillway river icing conditions.

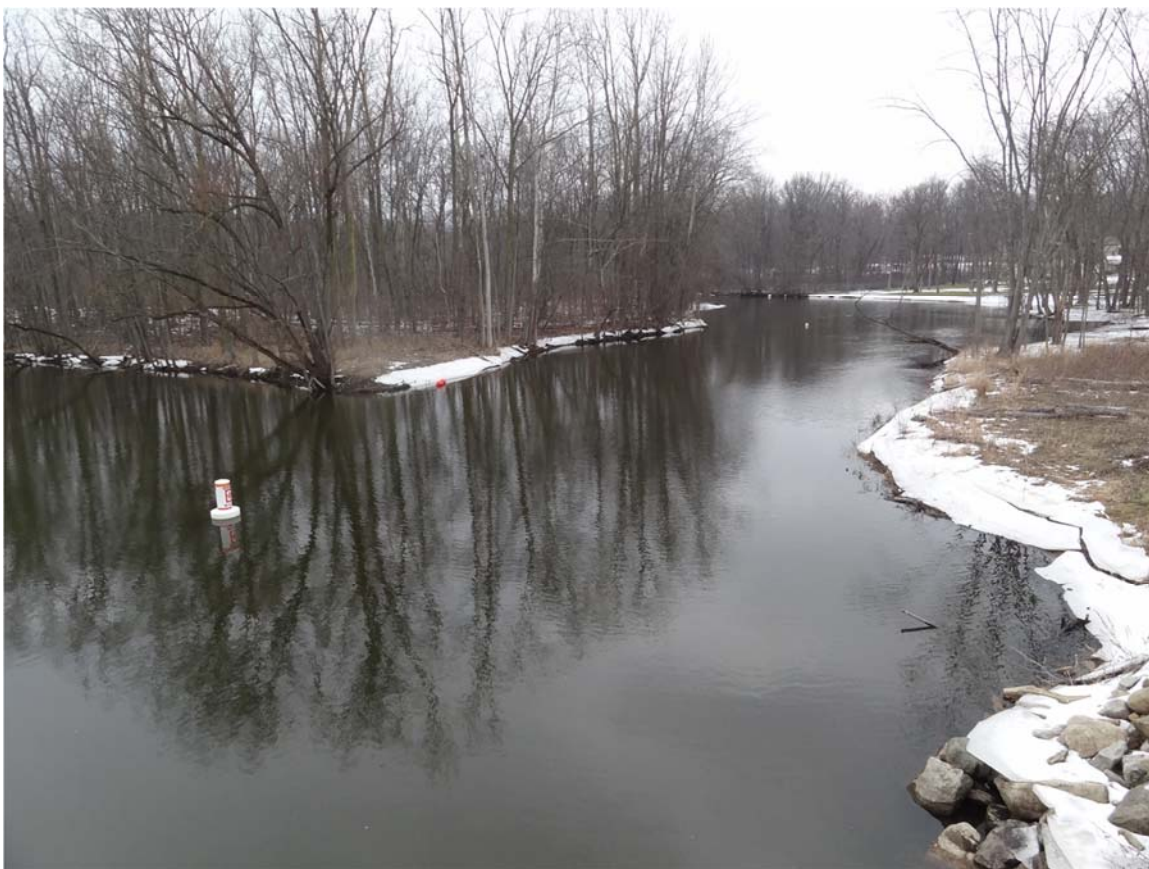
22. MP21.5 Sediment trap river icing conditions.

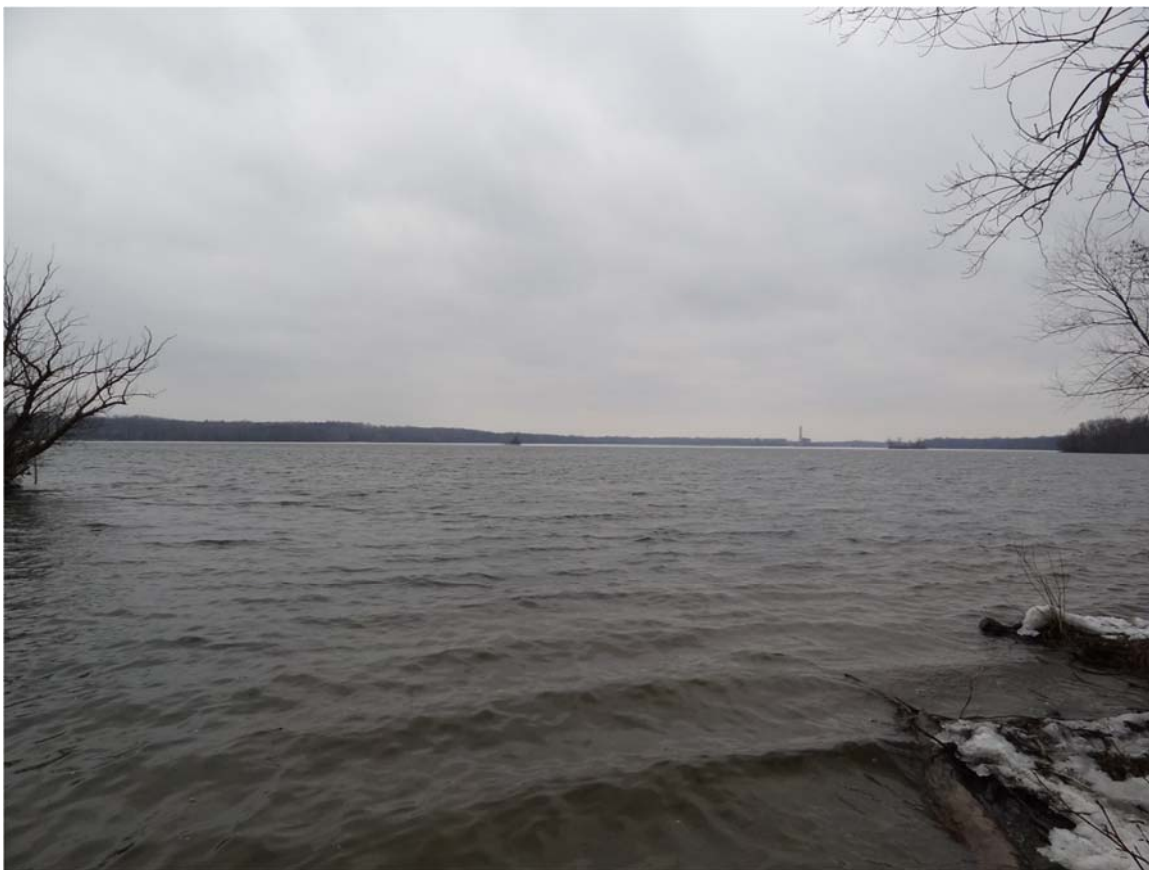
23. Morrow Lake icing conditions.

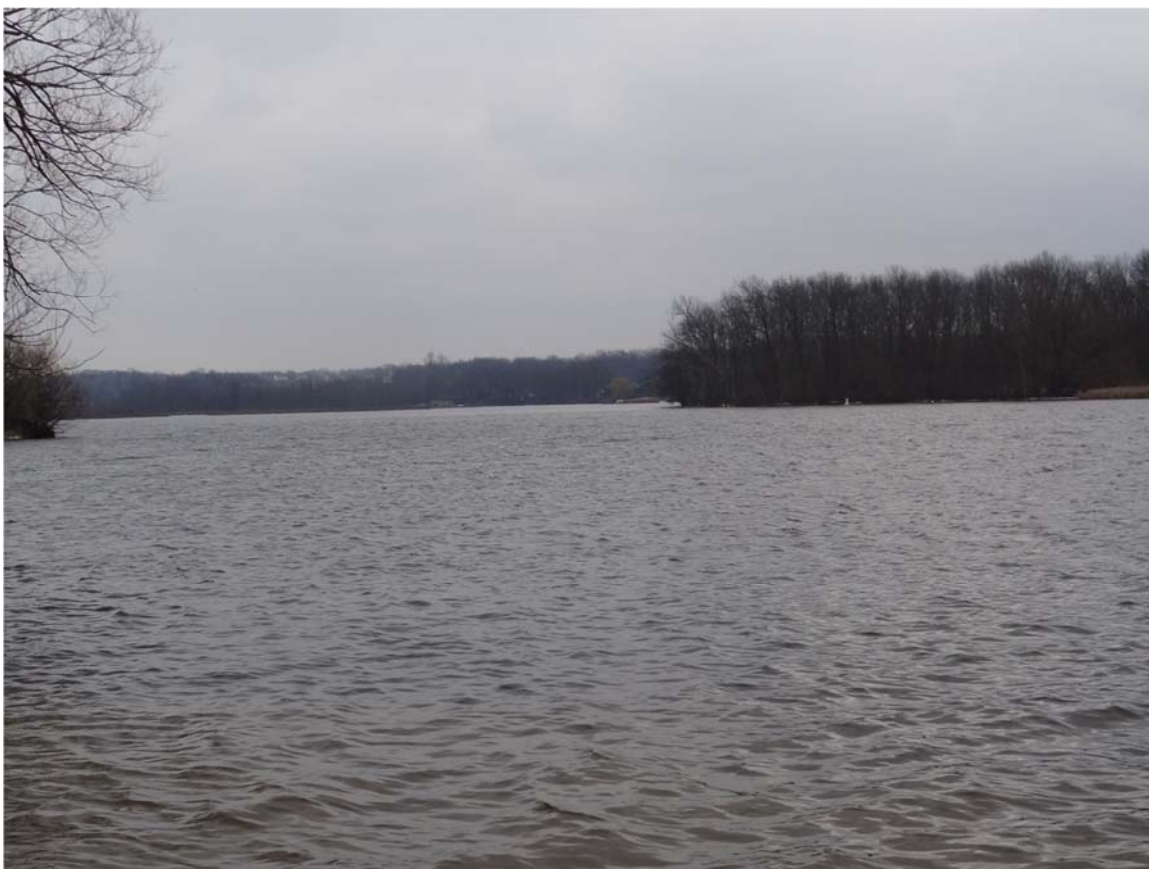
24. Morrow Lake Delta neck icing conditions.
